INSPECTION OF PAVEMENT GROOVING

Robert C. Gunkel

Army Construction Engineering Research  
Laboratory  
Champaign, Illinois

TECHNICAL REPORT NO. AFWL-TR-72-149

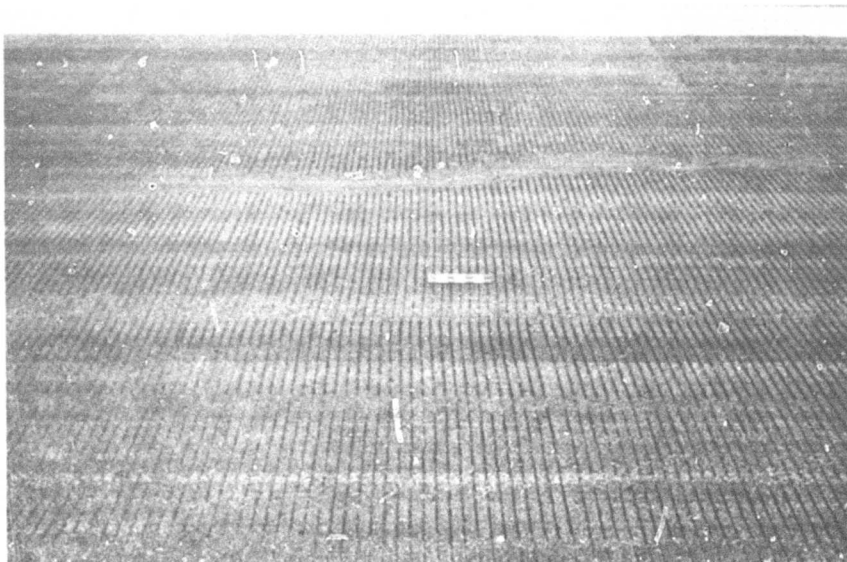
The general condition of the grooved AC overlay pavement was considered to be "very good" to "good" at the time of this inspection (Figure 1). Only a minor amount of deterioration has developed after 4 1/2 years of service under heavy traffic conditions. In one area, near the south end, some minor surface raveling of the grooves was observed (Figure 2). However, this condition was said to have occurred during sawing of the grooves. No maintenance of the grooved AC pavement has been required.

Figure 1. Kansas City Municipal Airport --  
Typical view of AC grooving

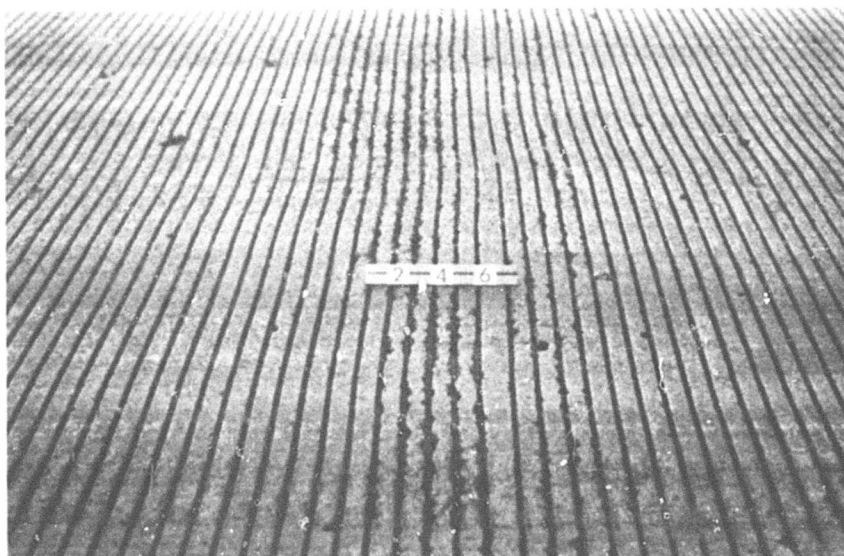
Figure 2. Kansas City Municipal Airport -- Deterioration  
of AC grooving located near runway end (36)

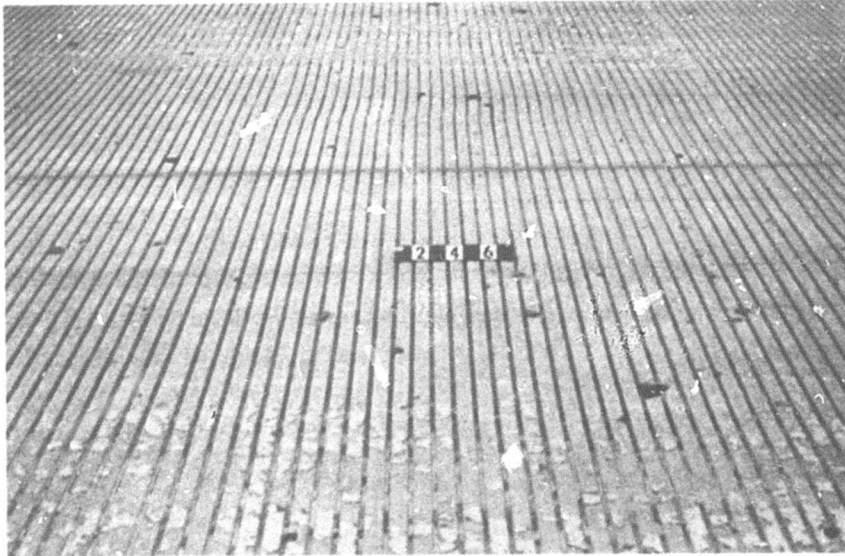
Figure 3. Kansas City Municipal Airport -- PCC grooving  
(small holes in surface are weatherouts).

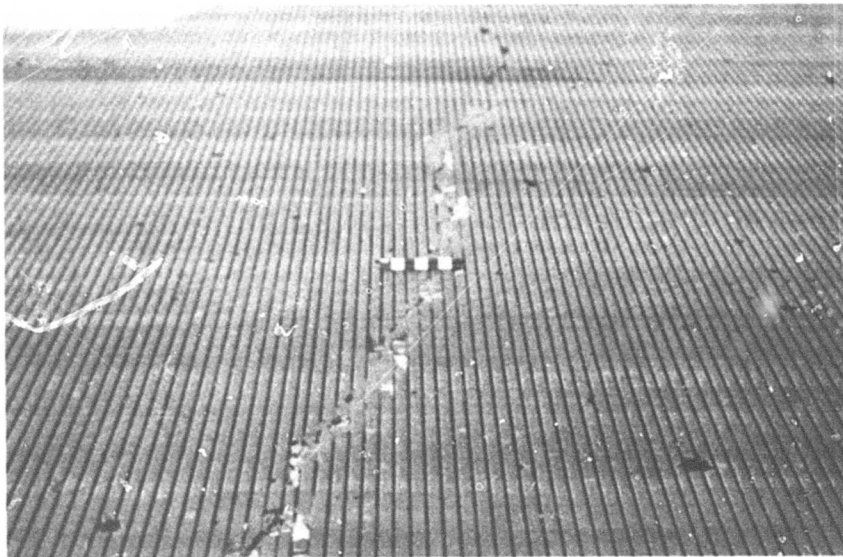
Figure 4. Kansas City Municipal Airport -- Transverse crack  
and surface voids located in PCC, 1500 feet from  
north end of runway.

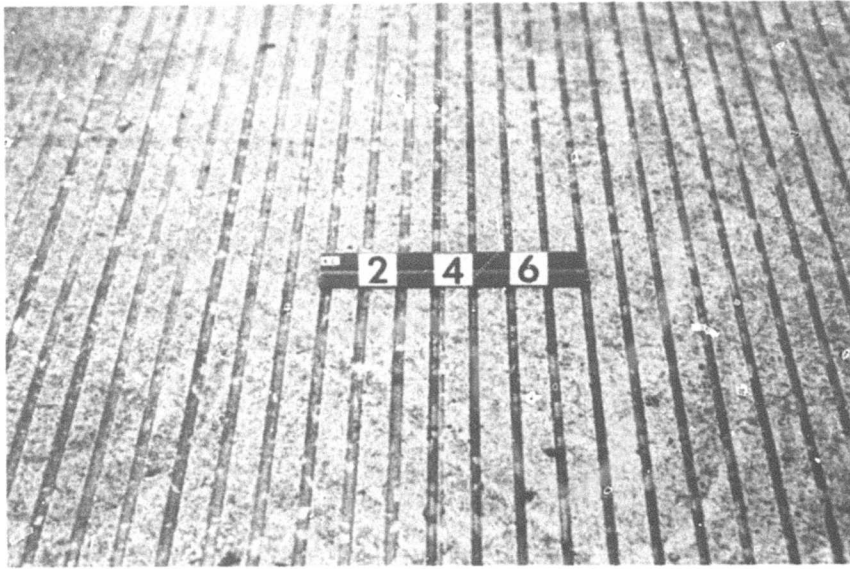
Figure 5. Kansas City Municipal Airport -- Typical view showing excellent condition of new PCC grooving.

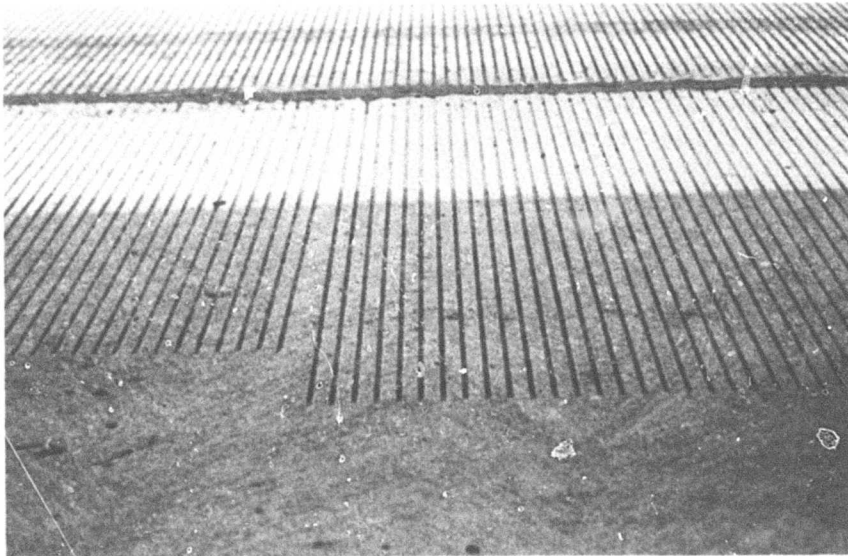
Figure 6. Kansas City Municipal Airport -- View showing how grooving operations end in AC shoulder pavement.

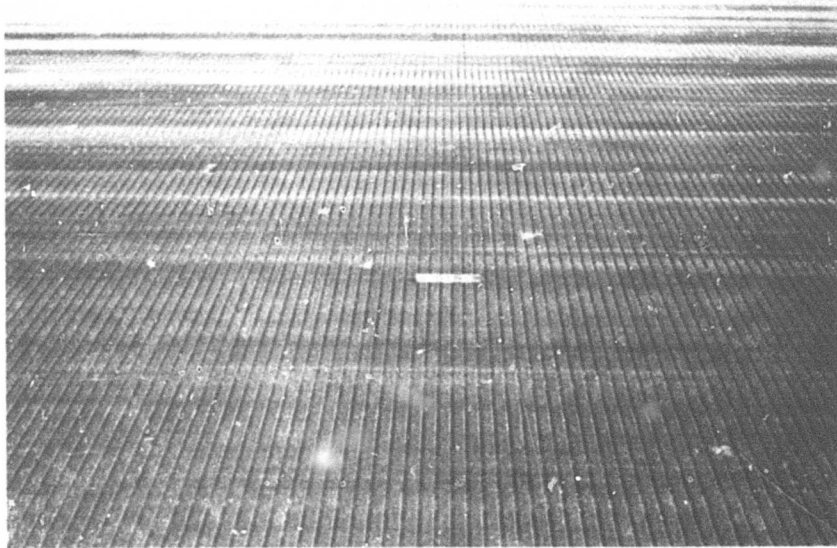
Figure 7. Chicago Midway Airport -- Grooved pavement in touchdown area, 1500 feet from southeast end of runway.

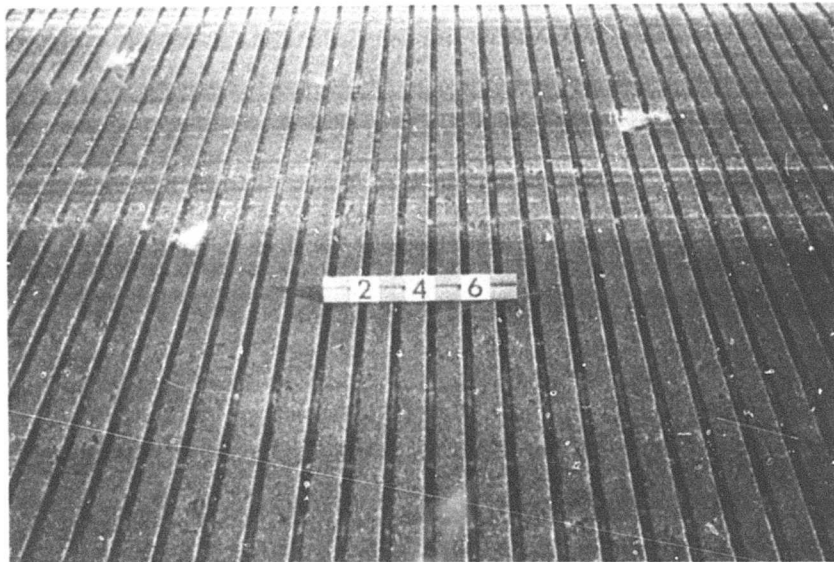
Figure 8. Chicago Midway Airport -- Close view in same area as Figure 7.

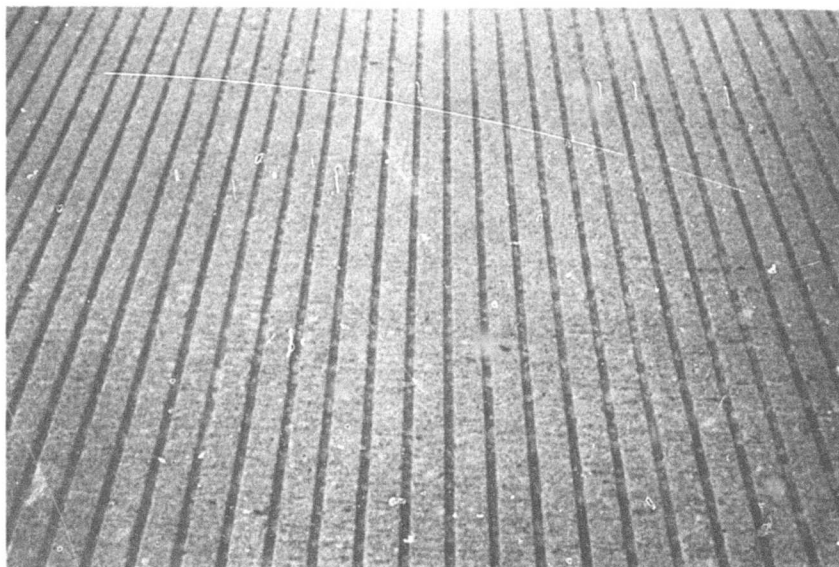
Figure 9. Chicago Midway Airport -- Excellent condition of grooving in southeast runway end.

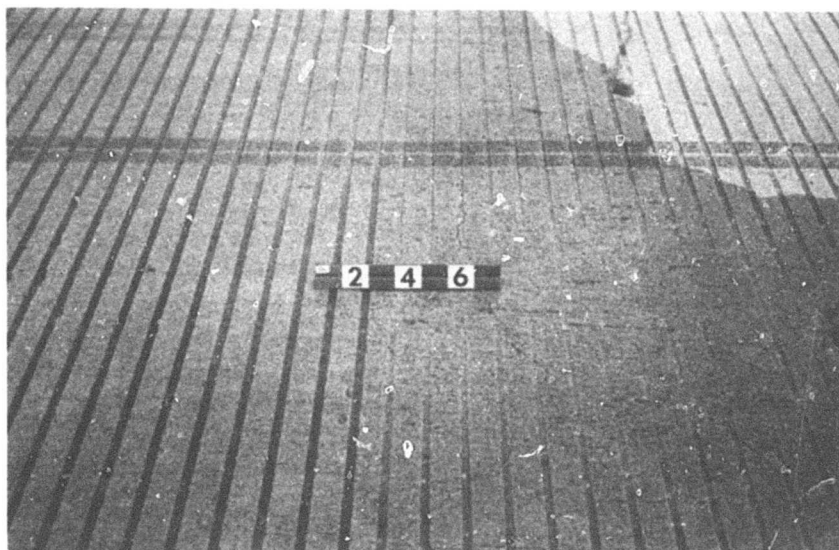
Figure 10. Chicago Midway Airport -- Deficiency in grooving due to low area in pavement surface.

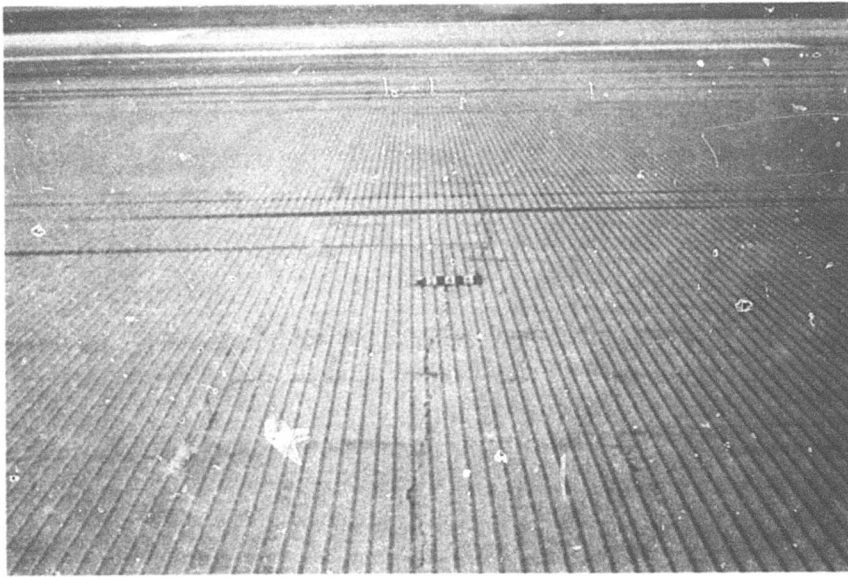
Figure 11. Chicago Midway Airport -- Typical transverse cracking found in continuously reinforced pavement.

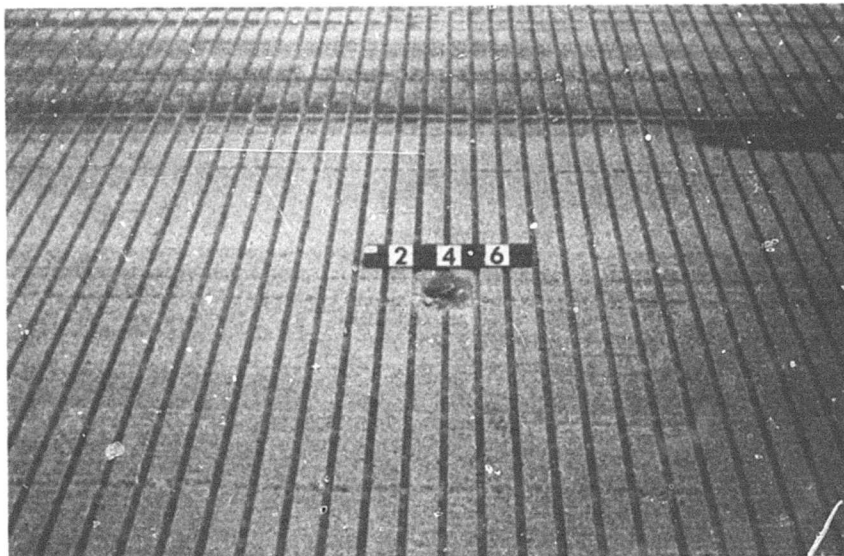
Figure 12. Chicago Midway Airport -- Close view of a weatherout, 1500 feet from northwest end of runway.

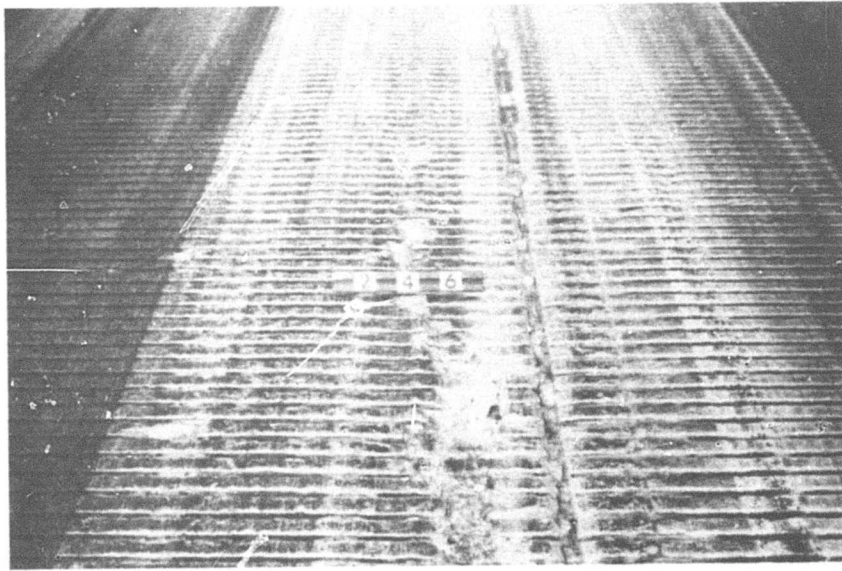
All of the pavement grooving observed at this airfield was in excellent condition (see Figures 7, 8, and 9). Tire marks were apparent in the touchdown areas, but there was little evidence of rubber deposits in the grooves. Several small areas of ungrooved pavement were observed where the grooving equipment had skipped over low places in the pavement surface (Figure 10). The continuously reinforced pavement had typical transverse cracks at closely spaced intervals, but there was little evidence of deterioration at intersections of the grooves with the cracks (Figure 11). A minor amount of surface voids were also noted (Figure 12). An extensive amount of spalling had occurred along the center longitudinal joint of the PCC pavement (Figure 13). This is

a structural problem which is not related to pavement grooving. Figure 14 shows a longitudinal joint spall repair made with a bituminous mixture.

Figure 13. Chicago Midway Airport -- Spalling along center longitudinal joint of runway.

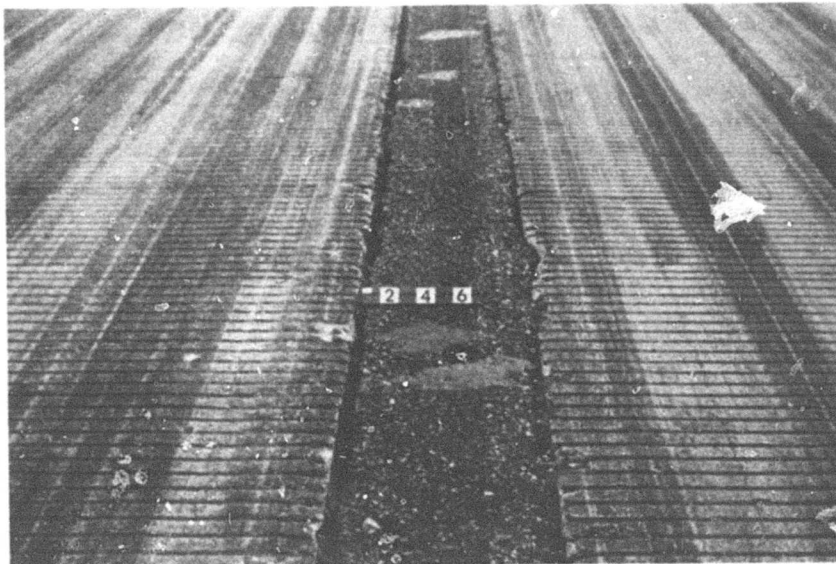
Figure 14. Chicago Midway Airport -- Joint spall repair made with bituminous mixture.

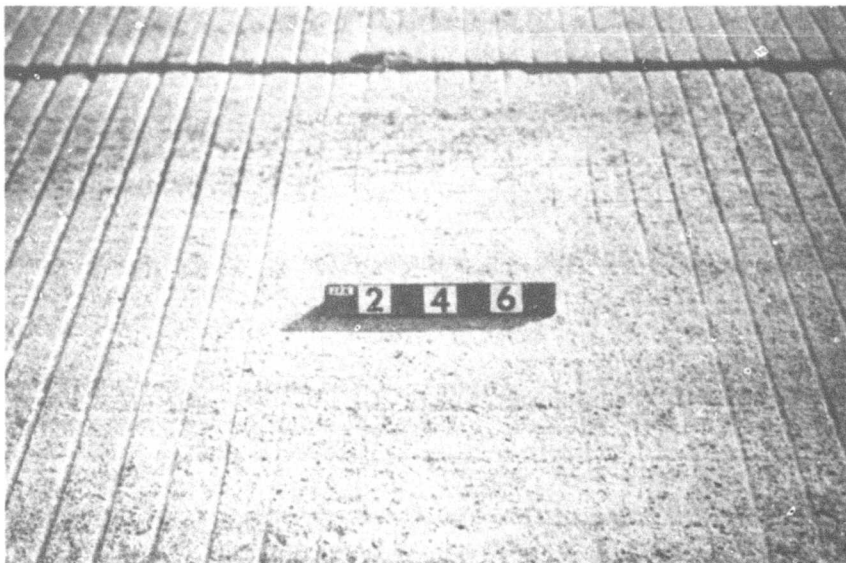
Figure 15. J. F. Kennedy International Airport -- Ungrooved area due to low place in pavement surface.

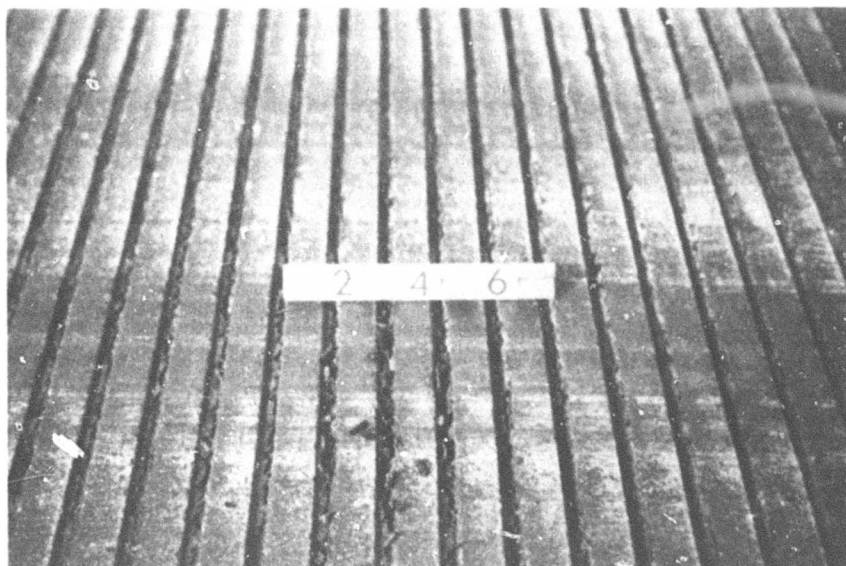
Figure 16. J. F. Kennedy International Airport -- View of rubber deposits in grooves in touchdown area.

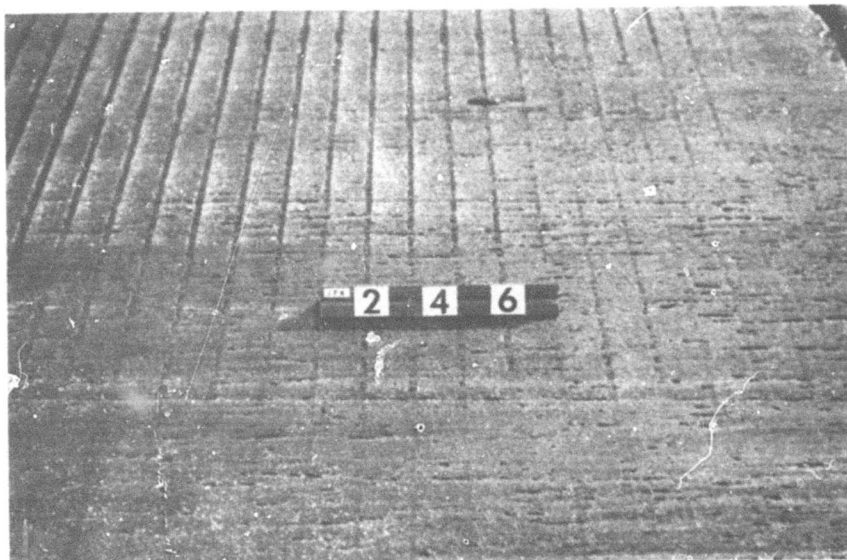
Figure 17. J. F. Kennedy International Airport -- Rubber accumulation completely filling grooves in touchdown area.

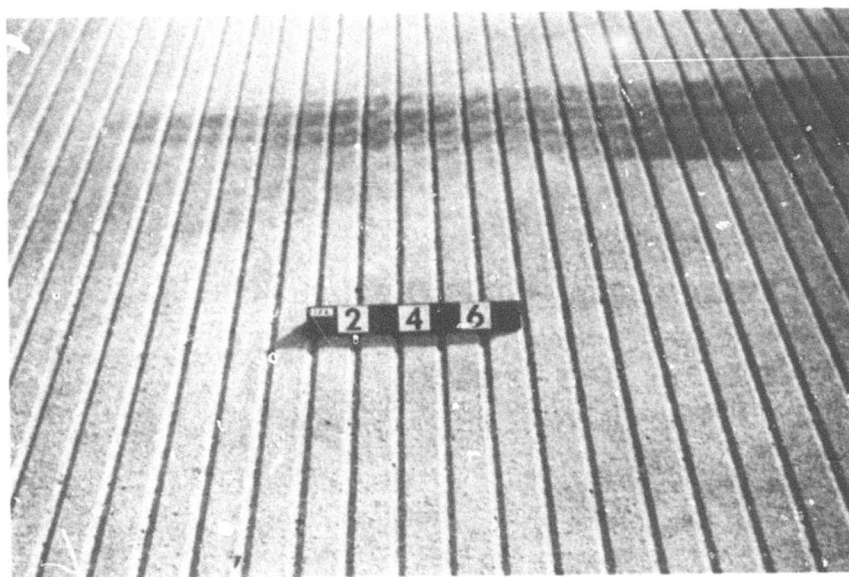
Figure 18. J. F. Kennedy International Airport -- Typical grooving in southwest runway end showing excellent condition.

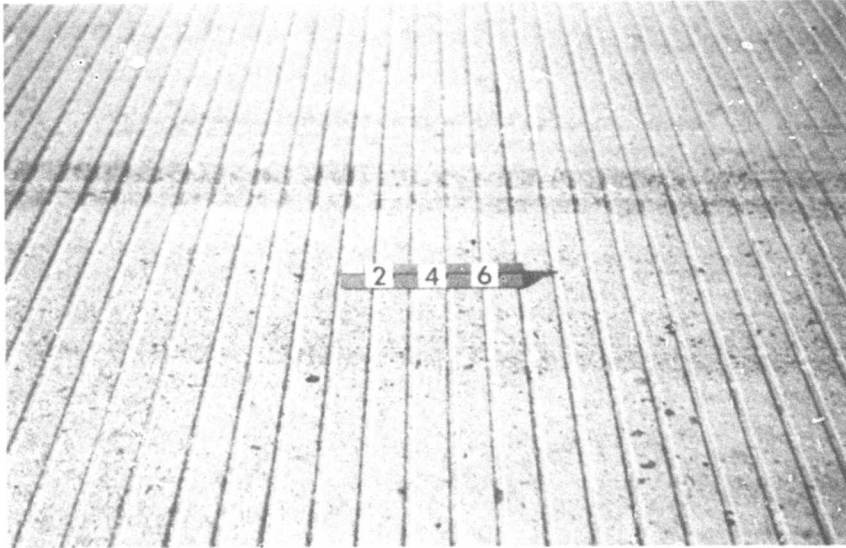
Figure 19. J. F. Kennedy International Airport -- Excellent condition of grooving in northeast end of runway.

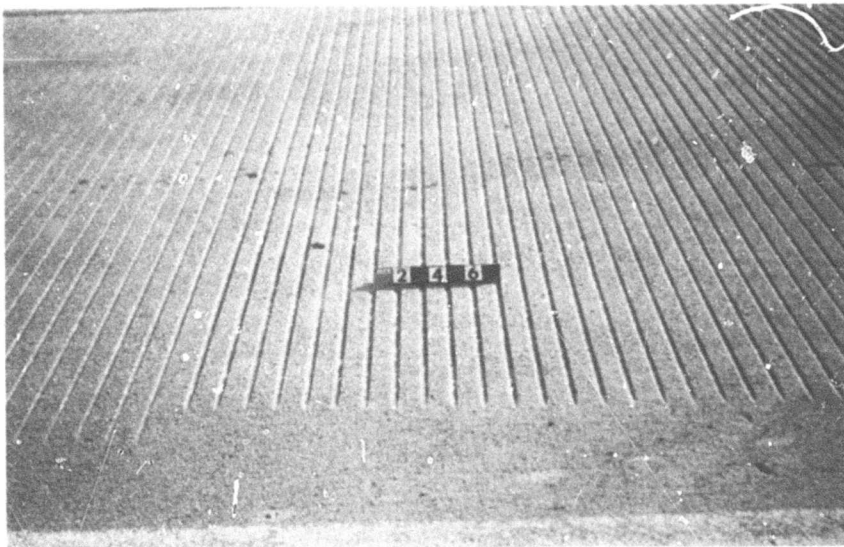
Figure 20. J. F. Kennedy International Airport -- View of outside traffic lane - grooving operations stopped within 5 feet of runway edge.

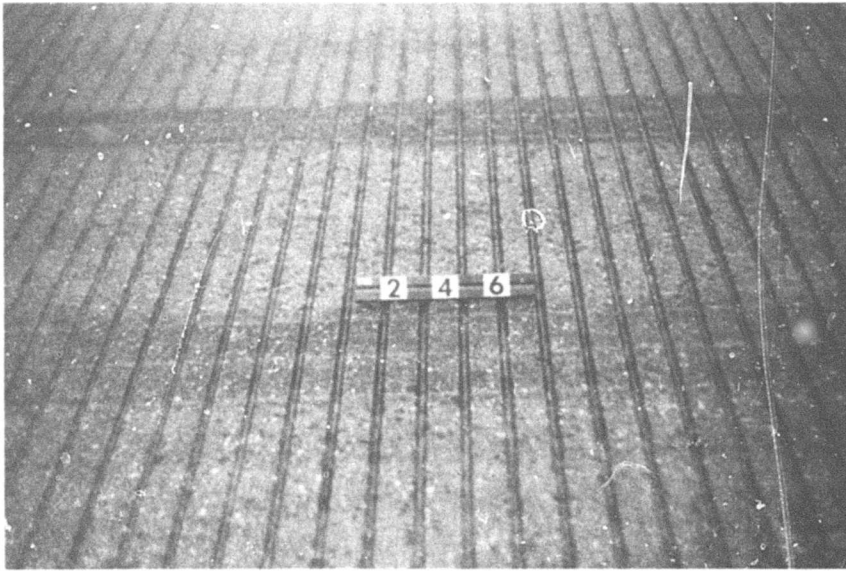
Figure 21 shows the grooving in the PCC deck at the northwest end of the runway. The grooves are sharply outlined and the beveled shape of the grooves may be detected. The grooved pavement was in excellent condition.

Figure 21. LaGuardia Airport -- General view showing excellent condition of grooving in PCC pavement - northwest end.

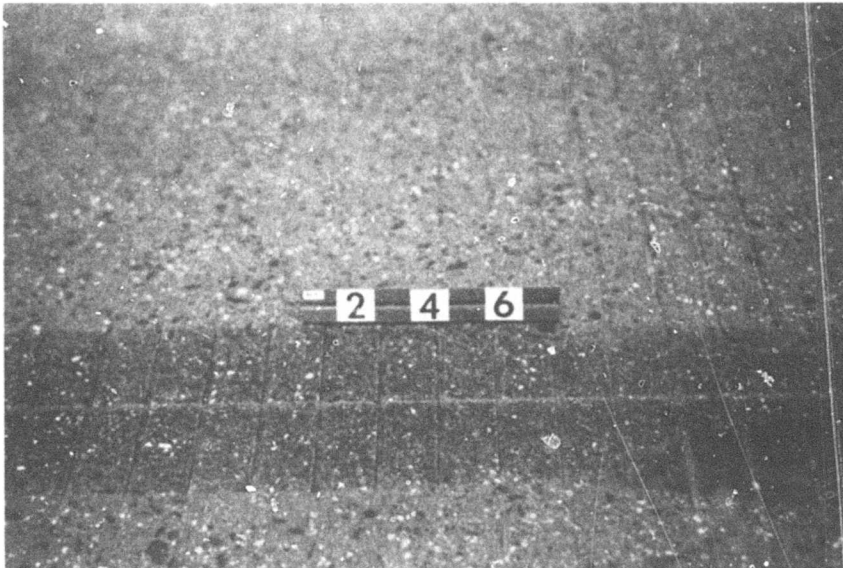
Figure 22 shows another view in the same general area as Figure 21. However, this portion was skipped over during grooving operations because of a low area in the pavement surface.

Figure 22. LaGuardia Airport -- Skipped area due to surface depression in northwest end of runway.

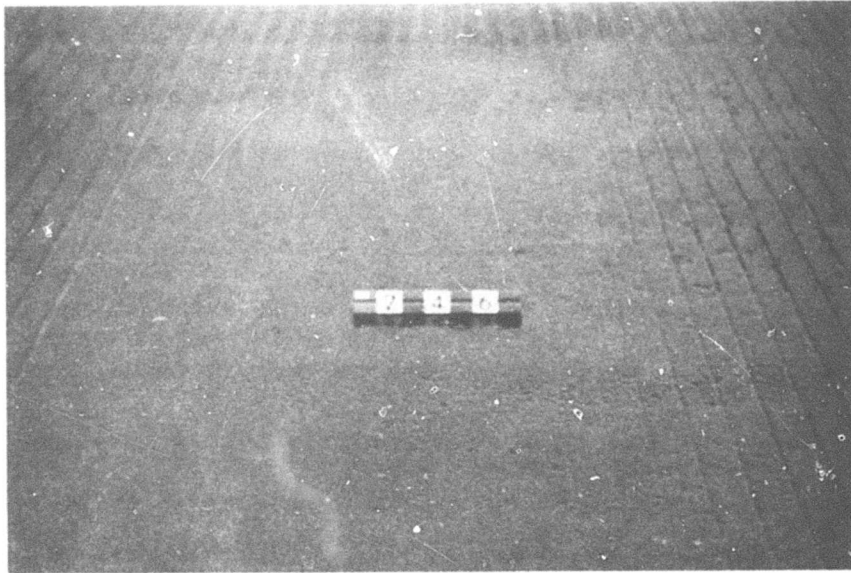
Figure 23 shows a small ungrooved area which was skipped during grooving due to a low place in the pavement surface. This is a deficiency in grooving and not a pavement deterioration.

Figure 23. LaGuardia Airport -- Close view of ungrooved portion of AC pavement.

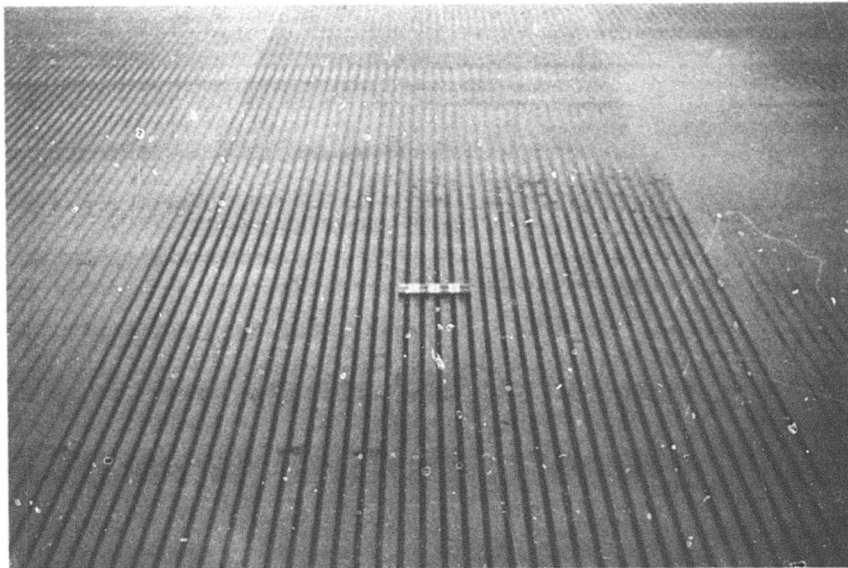
Figure 24 is a typical view of the grooving in Runway 13/31 AC pavement.

Figure 24. LaGuardia Airport -- Typical view of AC grooving in Runway 13/31.

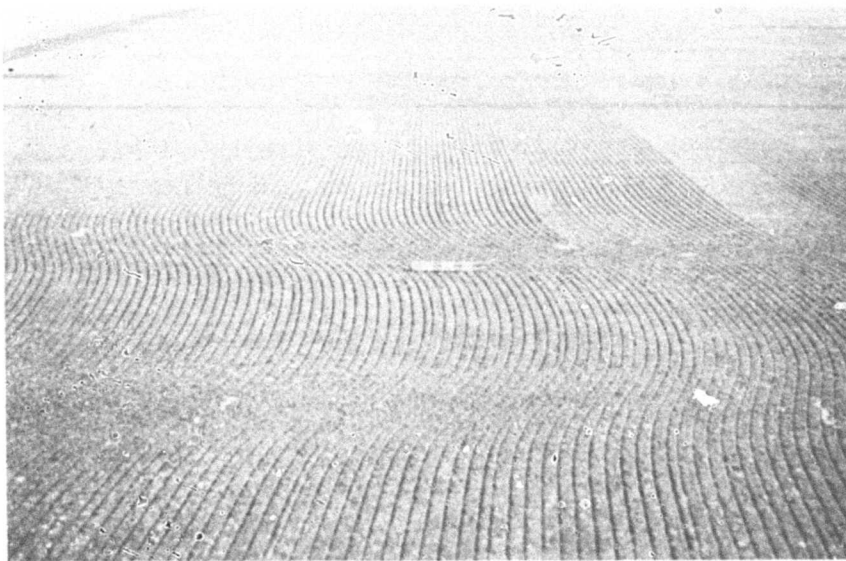
Figure 25. Washington National Airport -- Shifting of pavement surface in area of north end of runway.

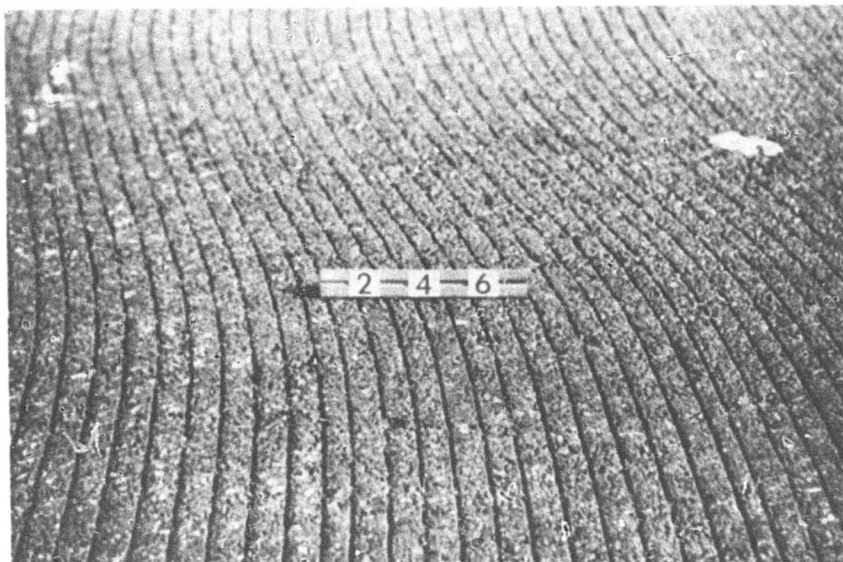
Figure 26. Washington National Airport -- Closeup showing distortion of grooves - same area as Figure 25.

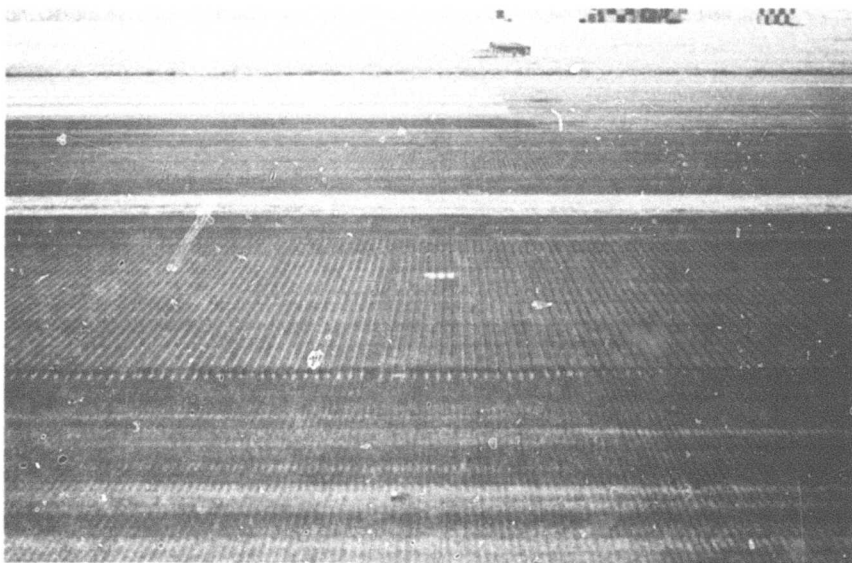
Figure 27. Washington National Airport -- View showing slightly elevated AC strips along center line of runway.

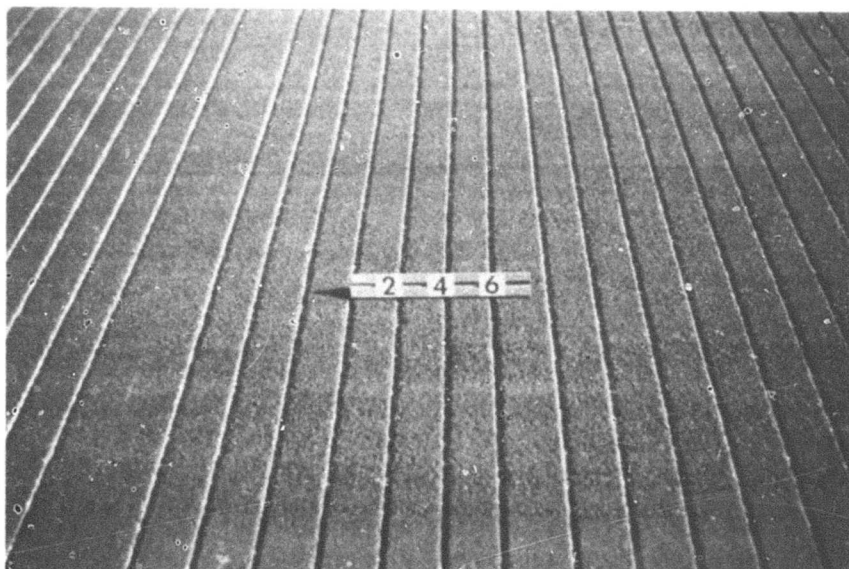
Figure 28. Washington National Airport -- Typical view of grooving on the AC strips.

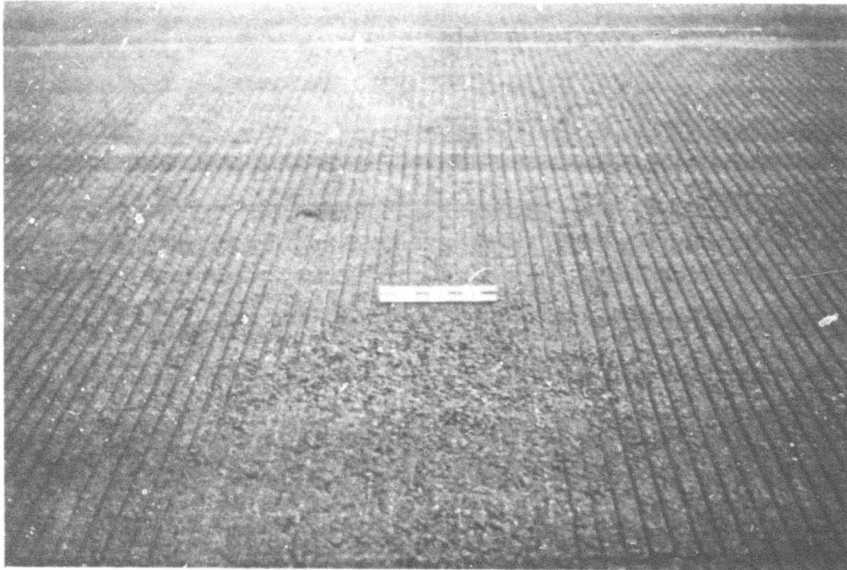
Figure 29. Washington National Airport -- Typical grooving in runway 18/36. Note rough textured AC pavement in foreground.

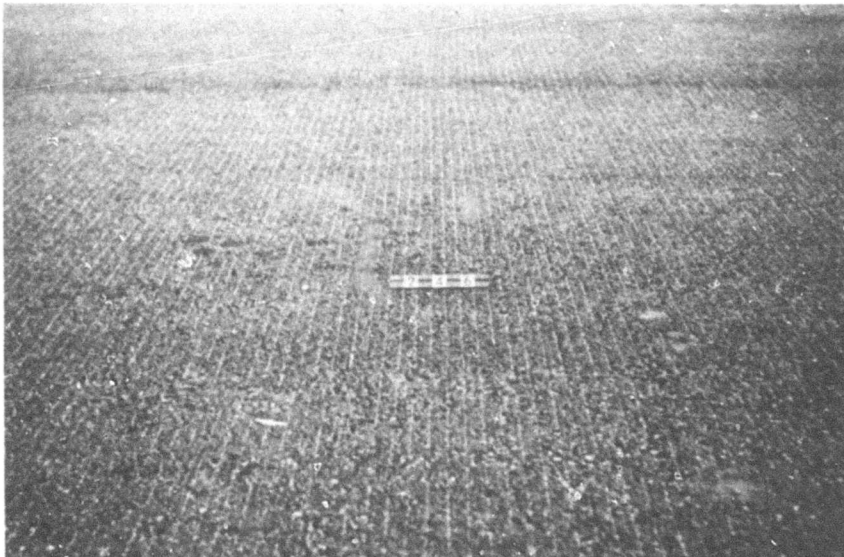
Figure 30. Washington National Airport -- Typical view of AC grooving near south end of runway.

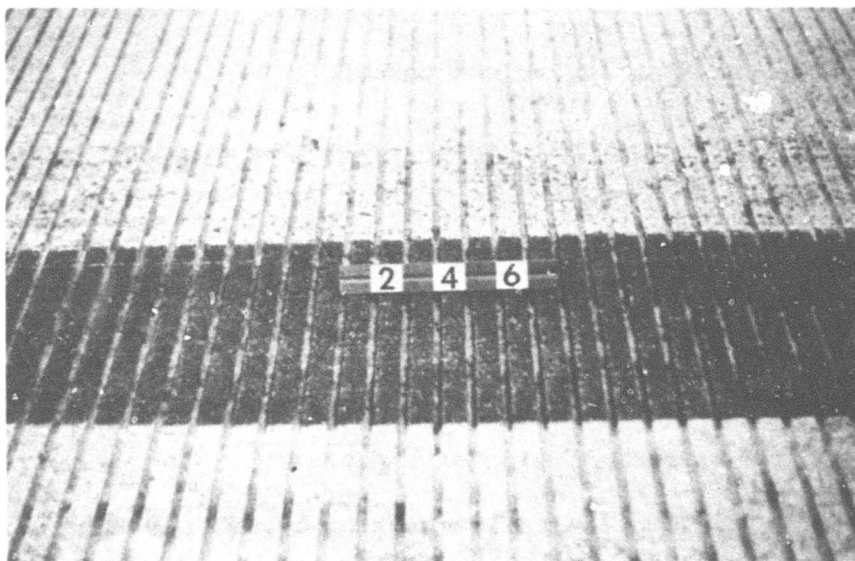
Figure 31. Beale Air Force Base -- Close view of tire mark showing some rubber deposits in grooves near south end of runway.

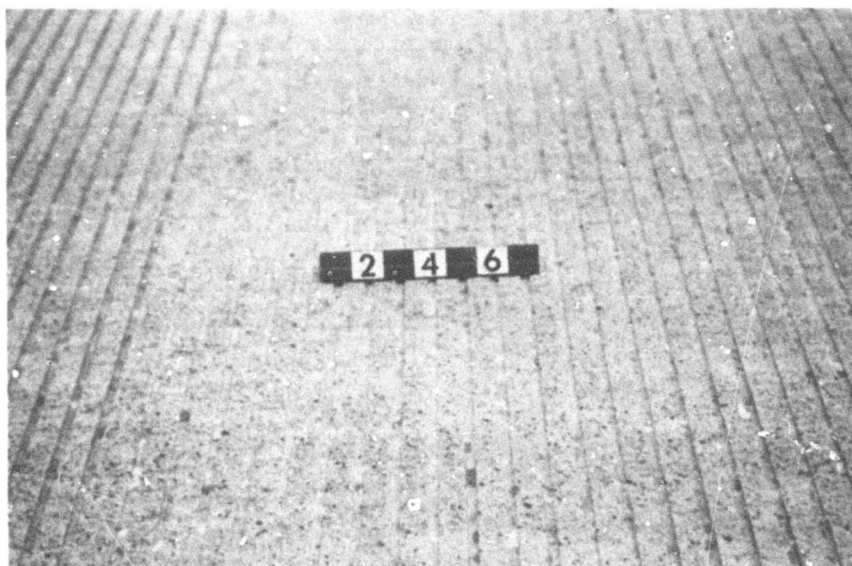
The grooved runway pavement was inspected on 26 January 1972, about 4 years after the grooving had been completed. There were very few surface defects and the grooved pavement appeared to be in the same condition as the ungrooved portion of the runway. Touchdown areas showed tire marks and only a small amount of rubber deposits were found in the grooves (Figure 31). The pavement surface was in excellent condition and there was no evidence of any deterioration of the pavement due to grooving (Figure 32).

Figure 32. Beale Air Force Base -- Typical grooving in Runway 14/32.

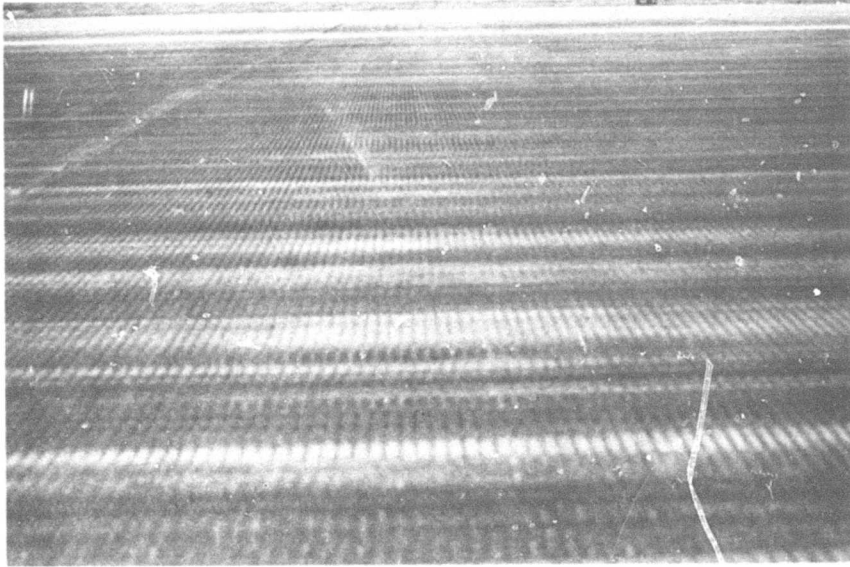
About 75 percent of the landings and takeoffs occur from the north end of this runway. During the inspection it was observed that the pavement surface was discolored from landing operations. However, the grooves were sharply outlined and the pavement was in excellent condition. This is evident in Figures 33 and 34.

Figure 33. Beale Air Force Base -- General view of grooved runway pavement 3000 feet from north end.

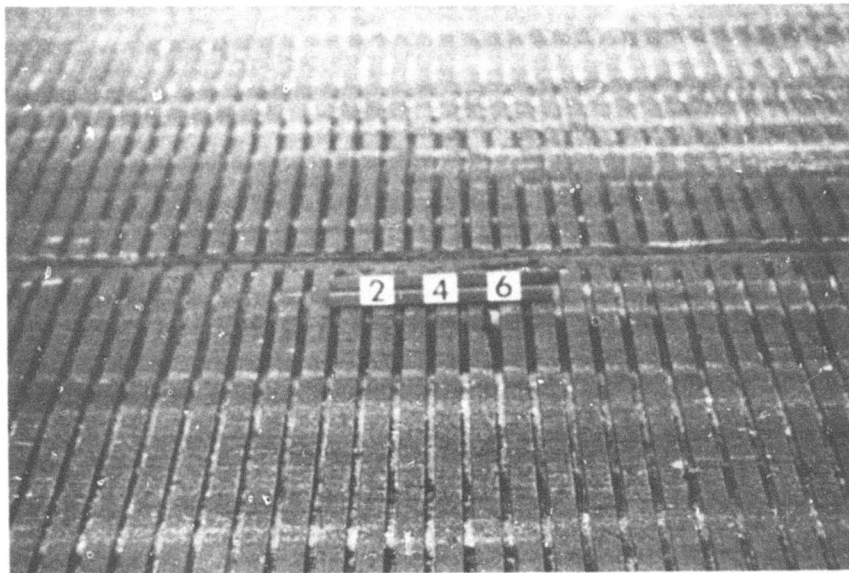
Figure 34. Beale Air Force Base -- Close view of PCC grooving in touchdown area north end of runway.
